Experimental investigations of power-actuated fastenings in TRC

A.D. Langenbeck^{a,b}, P. Spyridis^{a,*}, M. Beßling^a, J. Orlowsky^a

^a TU Dortmund University, Faculty of Architecture and Civil Engineering, August-Schmidt-Str. 8, 44221, Dortmund, Germany

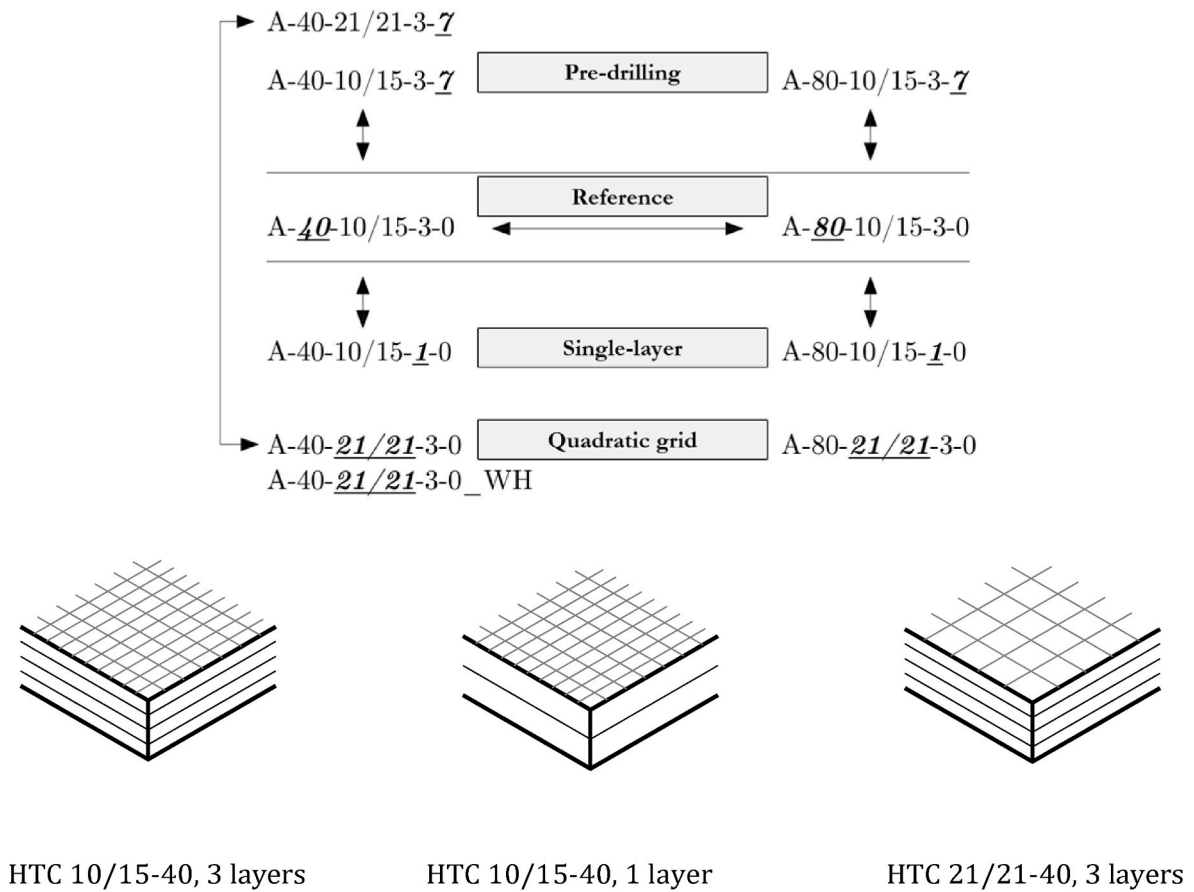
Fig. 2. (Top) Tested combinations of parameters; (bottom) Tested panel configurations.

The labeling of the experiments is done according to the properties shown in Table 1. The options listed are selected in any combination. The configurations A-40-10/15-3-0 and A-80-10/15-3-0 represent the two reference configurations. The suffix WH signifies a repetition of tests for a configuration that was investigated more closely and more results were required. Some of the 3-layer configurations were tested with and without predrilling. Fig. 2 shows the tested panel configurations schematically.

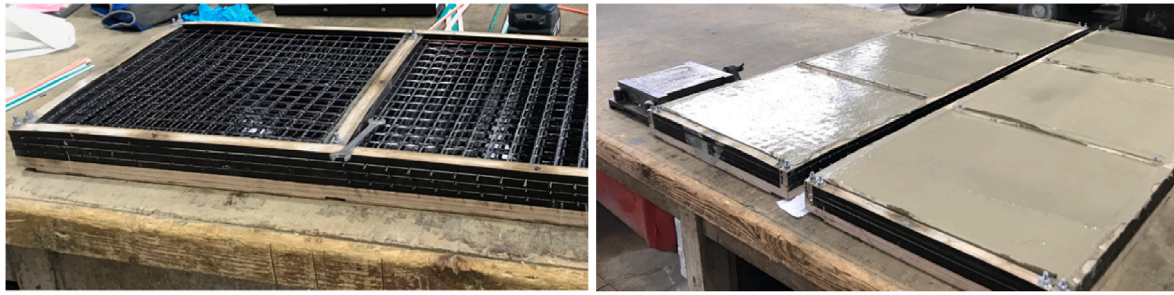
Fig. 4. Aspects of preparation of TRC panels and material testing prisms.

The TRC panels were produced through a horizontal casting process, aspects of which are shown in Fig. 4. To secure its position during casting, the textile was clamped at the edges of the formwork. Spacers were deliberately omitted to exclude a possible influence on the nail setting. In order to produce the concrete, the dry components were weighed and homogenised, water and superplasticiser were mixed beforehand, added to the dry components and mixed for approx. Another 5 min. Vibration time and formwork filling were regulated visually. The vibration process was generally kept short (approximately 30 s) to avoid segregation. A set of material tests prisms was nearly produced and stored in the same process as the panels. Another set was produced following DIN EN 196 [DIN EN 196-1] and stored according to [DIN 12390] (dry storage). The latter specimens were subjected to immersed and climate chamber curing. The TCR panels and the similarly produced set of prisms were placed together in the non-conditioned indoor environment of the laboratory, covered with a canvas until stripping and then wrapped in a wet canvas and tarpaulin in otherwise free air. Nail setting and its evaluation was always carried out on the 28th or 29th day.

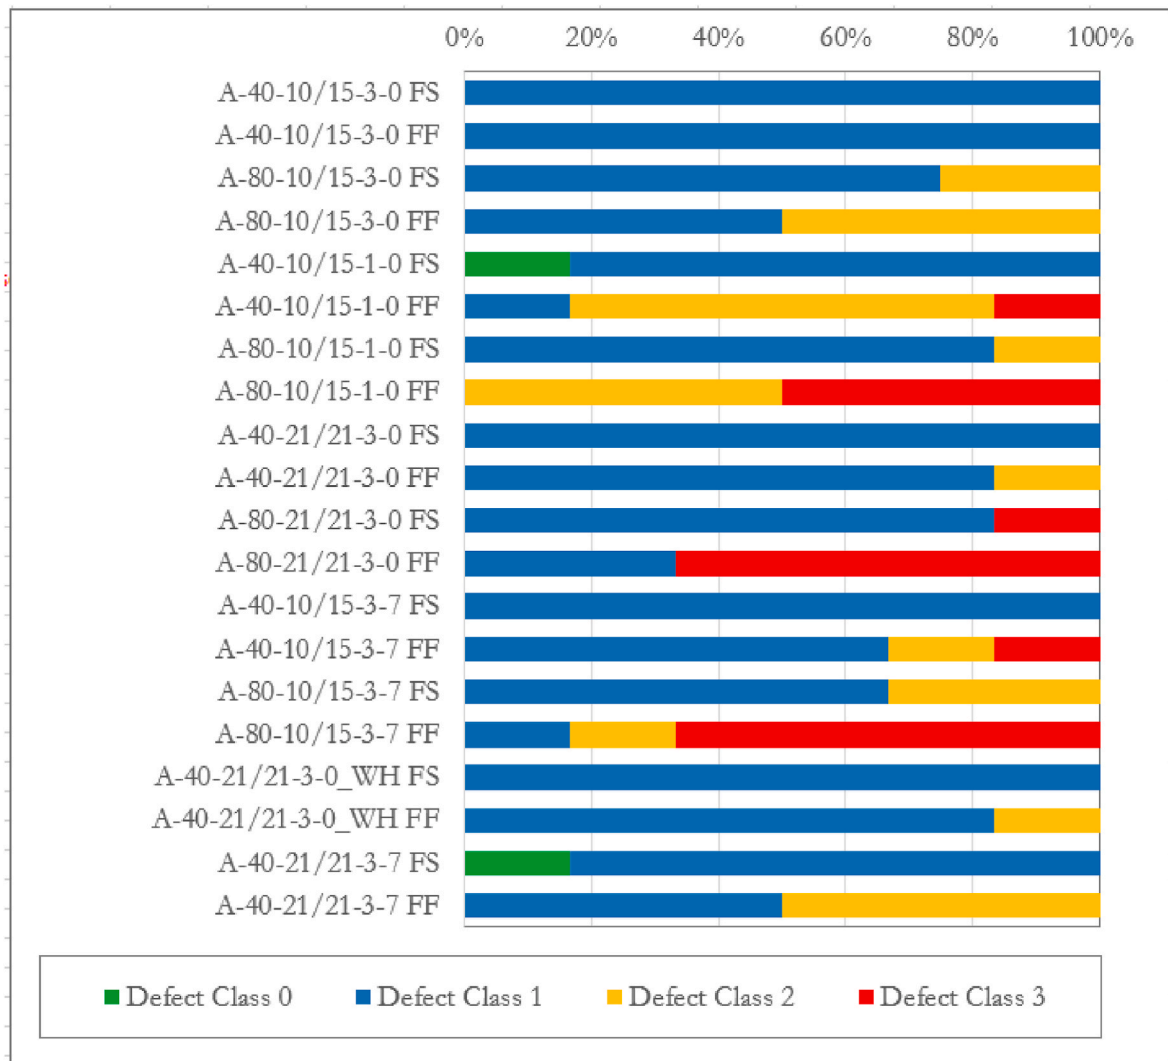
Fig. 8. Frequency of different quality/defect classes for each test series and each panel side (FS: fastening side, FF: fixture free face).

develop independently for each panel side. However, it is evident that the least overall damage was related to series A-40-10/15-3-0, as well as A-40-21/21-3-0 and its repetition A-40-21/21-3-0_WH (Fig. 8). Although this is counter-intuitive, the specific predrilling of 4 mm diameter and 7 mm depth carried out in these studies does not appear to consistently influence the nail installation quality positively or negatively in terms of defects on the panels.

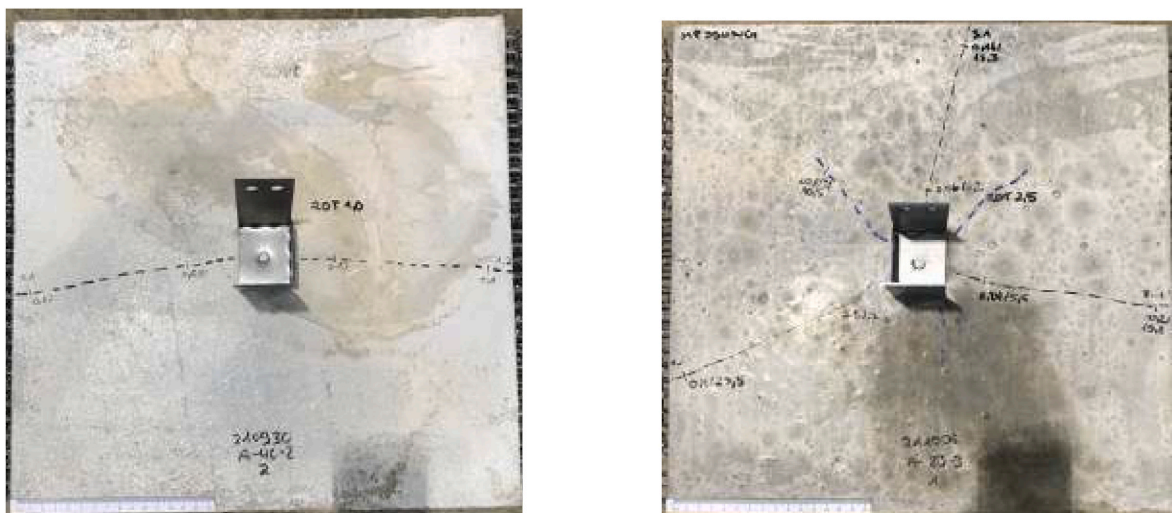
Fig. 9. Crack patterns 1-A (left), 1-B (right).

With regards to the crack pattern, an additional distinction was carried out. The following two features characterise the crack patterns (See also Fig. 9).

- Crack pattern A: Cracks running perpendicularly to the panel edges, following the weak orthotropic direction of the textile, parallel or quasi-parallel to warp. There is one prominent crack with a large crack width since it absorbs the component of all strains in the panel.
- Crack pattern B: Cracks starting radially from the nail in different angles, possibly - but not necessarily - including cracks in the orthotropic directions. The crack pattern appears more uniform also with regard to the crack widths.

The crack pattern A was predominantly evident in rectangular textile configurations (73% of all cases), whilst pattern B governed panels with a quadratic textile configuration (83% of all cases). For the predrilling tests alone, these quotas change slightly, but overall the influence of predrilling in both cases does not appear to determine the cracking pattern. Panels with a single textile layer exhibited an overall maximum crack width of 0.40 mm, while panels with three layers had a maximum crack width of 0.22 mm for crack pattern A and 0.16 mm for crack pattern B.

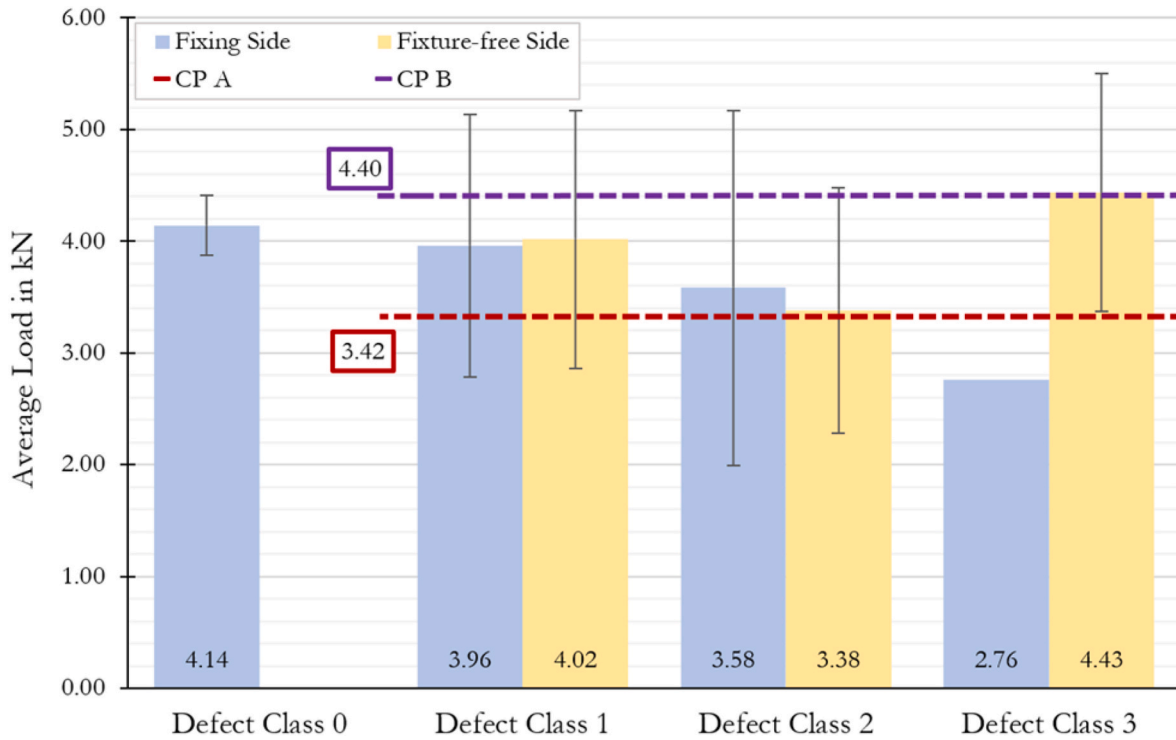
Fig. 11. Correlation of nail resistance with panel damage patterns due to installation for all tests, distinguishing the defects class on the fastenings side and the fixture free face of the panel (CP: Crack Pattern).

As noted in the previous sections, it is quite unlikely to avoid even minor cracking or local damage around the nail during installation. As shown in Fig. 11, the defect class on the fastening side correlates clearly with the pull-out loads, as it exhibits higher mean values and smaller scatter when installation defects decrease. On the contrary, defects on the fixture-free face do not influence the load resistance of the nail, understandably because the load-bearing area is mainly at the shank perimeter. The graph also distinguishes the load resistance of nails associated to the two different crack patterns (CP) A and B. Here it is made evident that nails in a single crack (CP A), carry an approximately 25% lower load compared to nails in panels with a pattern B of radial cracking. In this representation, it is also interestingly noticed that nails with a crack pattern B perform better even than the nails in undamaged panels (DC 0); this may imply that a mild cracking around the nail can absorb high local stresses and facilitate a better load-bearing performance in comparison to intact TRC that fully resists local damage. Still, given the very small sample size for DC 0 ($n = 2$), this should only be treated as a conjecture.
