Validating the performance of direct fastening (PAF) into concrete with high-speed measuring technology

Ronja Scholz¹ | Pascal Franck¹ | Alhussain Yousef¹ | Panagiotis Spyridis^{1,2} | Frank Walther¹

Abstract

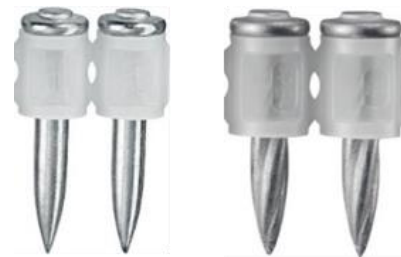
Figure 3 Nail-type fasteners used in this study: round shank nail (left), and spiral shank nail (right)

compaction and plastification at the fastener's region. A theoretical performance of the material surrounding the nail is shown in Figure 2. Real marketed products, in particular those applied in the studies herein, are shown in Figure 3.

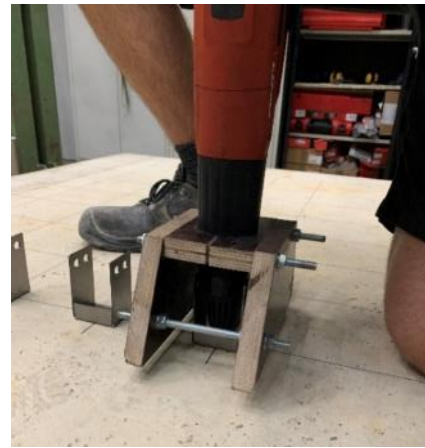
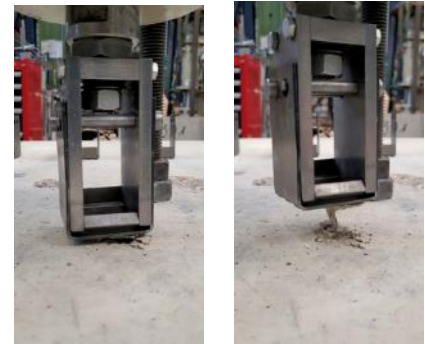
Figure 5 Installation set-up, using nail with light steel pull-out adapter and power actuated tool (top); Test configuration of pull-out test in two phases (bottom), indicating spalling at installation and bend nail at pull-out.

For the experimental investigations concrete specimens were cast with a composition of steel fiber reinforcement where used. In particular, the steel fibers used were of the commercial product Dramix by NV Bekaert SA, 4D 65/60BG [15]. The fibers are wire filaments of cold drawn wire with a diameter of 0.9 mm and hook-shaped ends, while their nominal material strength is 1600 MPa . As a consequence, the 4D steel fibers' efficiency is understood to be higher than 3D in crack bridging in terms of pull-out from the matrix as well as steel fiber rupture. The concrete mix was otherwise produced per testing standards for fastenings [18]. It is noted that, although measurements on single nails with CT and high-speed apparatus was conducted, at the time of this investigation and inception of this report, pull-out test series in plain concrete were unavailable. The concrete class was C20/25 with and 40 kg/m^3 steel fibers, Rhine River gravel including aggregates of $0/2 \text{ mm}$ at 36% , $2/8 \text{ mm}$ at 34% , and $8/16 \text{ mm}$ at 30% and with 235 kg/m^3 cement at a w/c ratio of 0.75 . On the form-work side each slab, 80 fasteners of each fastener type shown in Figure 3 were installed. Both these nail-type fasteners have a shank length of 27 mm and a diameter of 4 mm . For the pull-out tests, the fasteners were installed through a cored thin steel sheet adapter, which is laser cut and folded appropriately for the connection to the pull-out apparatus, as seen in Figure 5.

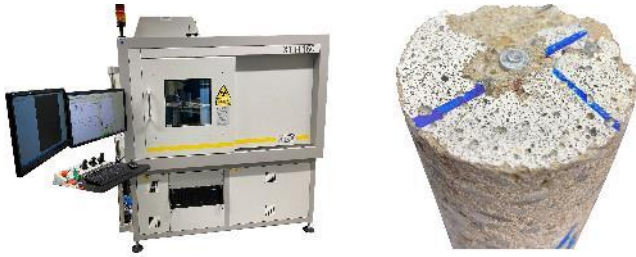
Figure 6 Computer tomography system and specimen.

After the setting process was done successfully, the concrete specimens were investigated using the technology of computed tomography. The scans were carried out on the XT H 160 of Nikon (Figure 6) that contains a microfocus X-ray tube with a maximum voltage of 160 kV . The specimen is located on a 5-axis manipulator that allows a full rotation of 360 degrees. The X-rays radiate the concrete specimen and are collected on a detector with a size of 1024×1024 pixels. Due to the rotation of the specimen multiple recordings of the specimen from a differing angle are taken, out of which a 3-dimensional volume can be reconstructed.

Because the concrete blocks in which the nails have been set were too massive to be radiated by the CT, it was necessary to drill out the nail and the surrounding concrete. Therefore, a core drill bit with a diameter of 60 mm was used to get the specimens in a fitting size as shown in Figure 6.

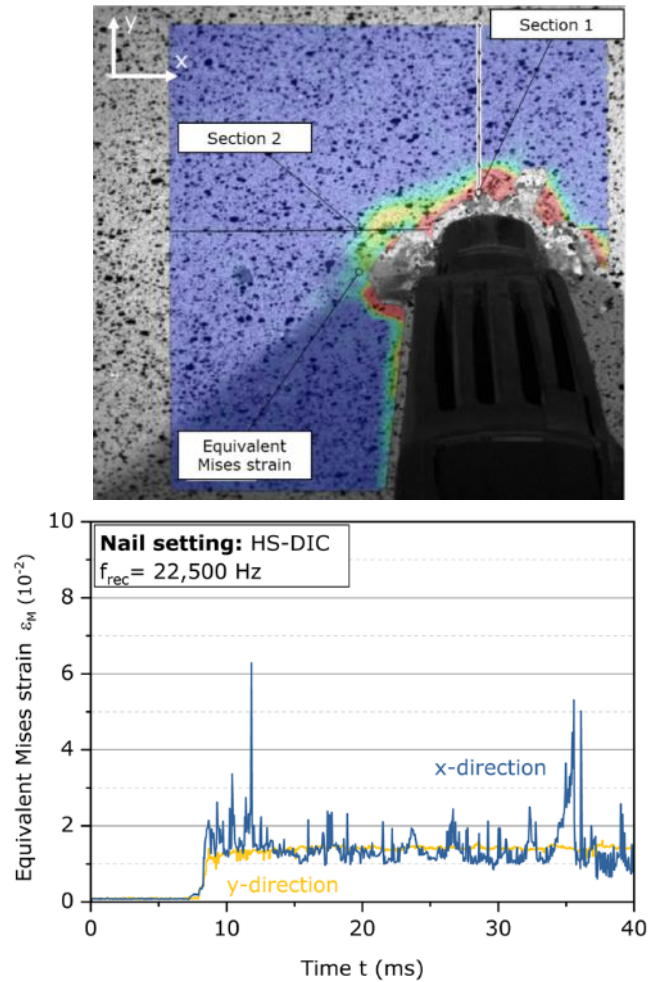
Figure 7 Exemplary representation of the strain measurement via high-speed-DIC, top: marked points for section 1 and 2 and bottom: calculated von Mises strain for the two sections.

Figure 7 shows the strain recorded via high-speed cameras with subsequent DIC-analysis exemplary for the combination of standard concrete and the round shank nail nail. First it can be seen that there was a slight difference in the calculated equivalent Mises strain ϵ_M in x- (section 2) and y-directions (section 1). The mean value of the strain for both directions is shown in Figure 7 as well. At the beginning of the testing procedure, the strain is around 0%, since the nail was not set into the concrete. With the nail being set, the strain for both sections increases abruptly. It can be seen, that the strain is around 1,5 % for both sections. The scattering is bigger for the x-direction, which can be attributed to the spalling of the concrete parts flying through the camera image, leading to calculation inaccuracies.

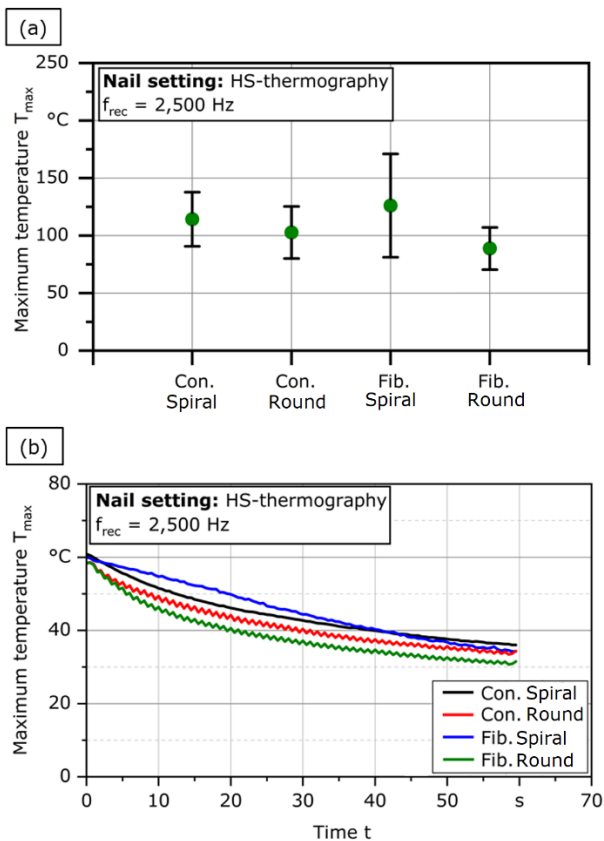
Figure 9 Temperature evolution following the nail setting process recorded via high-speed thermography, (a) maximum temperature and (b) cooling process in the first 60 seconds.

The results of the thermographic recordings of the setting process for the previously mentioned combinations of nail and concrete type are described in the following section. In Figure 9 (a) the maximum temperatures of the surrounding concrete immediately after the setting process are shown for the 4 different material combinations. It can be seen, that the maximum temperature was higher for the spiral shank nail. The highest temperature of around 130°C was recorded for the combination of the spiral shank nail and the fiber concrete. The high standard deviation shows that the maximum temperature was varying for this material combination. For the round shank nail the recorded maximum temperature was around 100°C for both of the types of concrete. The standard deviation was lower than the one for the previously mentioned material combination, making the temperatures for the round shank nails more comparable.

Figure 9 (b) shows the cooling process of the concrete surface surrounding the nail, recorded with a frequency of 2 Hz for the first 60 seconds. The cooling process again shows a difference between the two nails. In the first place, all material combinations start around a temperature of 60°C. After that, the round shank nail shows a stronger nearly exponential cooling in the first 30 seconds. The cooling of the surface surrounding the spiral shank nail is nearly linear compared to the round nail, leading to a higher surface temperature in the first 30 seconds for the spiral shank nail.

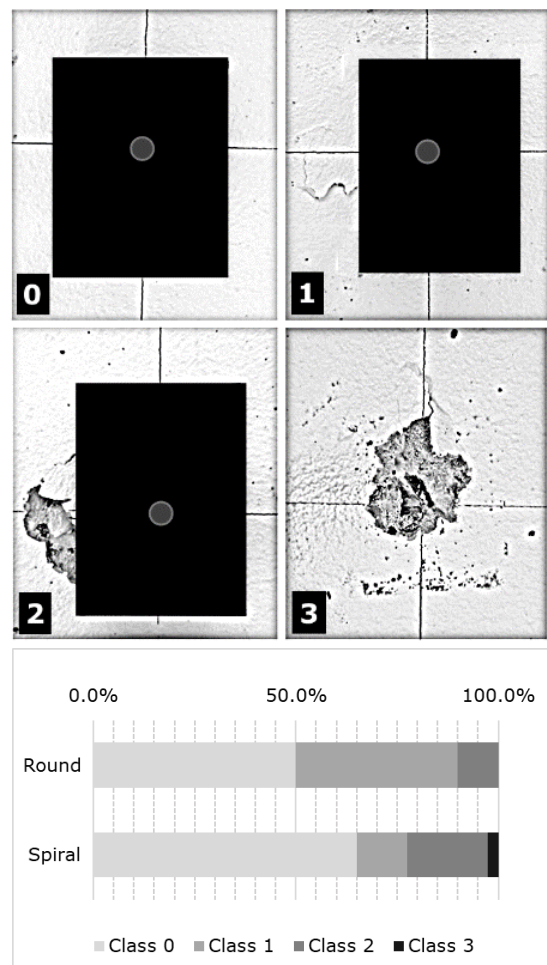
Figure 10 Top: sketched classification of nail setting performance beyond the nail and fixture (shaded area); bottom: frequency measurements in 80 nail setting series.

The assumed damage in the setting point vicinity is visually assessed and classified as follows:

- Class 0: no obvious damage
- Class 1: radial cracking with a finite length
- Class 2: circular cracking and surface spalling
- Class 3: setting failure, immediate loss of nail

As seen in Figure 10, stick rates were 100% and 97.5% for the round and spiral fasteners respectively. At the same time, the spiral fastener apparently has a better overall setting performance in terms of surface cracking/spalling, with 65% completely intact installations. These statistics hardly allow further distinction with respect to the nail-type, but by comparison to previous experiences in plain concrete – as for example also indicated in Figure 1 – a tendency is discerned that the setting performance in steel fibre concrete is superior to the ones obtained in plain concrete.

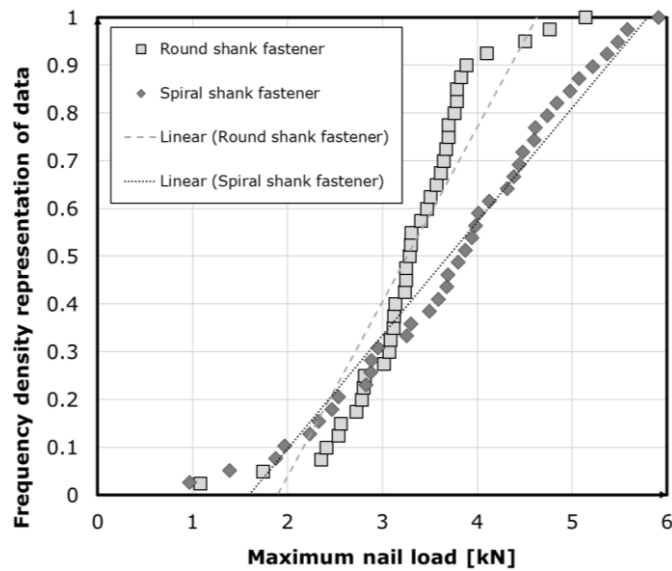
Figure 11 Cumulative frequencess of pull out load test results and indicative linear trendlines.

The data collected through pull-out testing refer to the maximum load. The loads are represented in Figure 11 in the form of cumulative density graphs. An overview of the results is also provided for clarity in Table 1: minimum value (excludes null due to setting failures), maximum and average values, the coefficient of variation and the statistical moments of standard deviation, skewness and kurtosis (the latter two are noted to merely complement the chosen best-fit distribution curves). A principal finding is that in none of the series the minimum load does approach null, which suggests that nails with apparent defects are likely to still entail a considerable load-bearing capacity in steel fibre concrete. The spiral nail fastener types yield generally higher values at average and maximum values compared to the round nail, but also somewhat higher scatter. The coefficients of variation are 22.4 and 32.3 for round and spiral nails respectively. It should be noted, that a full comparison of the variation and low load behaviour is difficult due to the limited sample size and low distribution density for lower quantiles.
