# More durable modular expansion joint constructions for road bridges

Dieter Ungermann<sup>1</sup> | Bettina Brune<sup>1</sup> | Michael Diener<sup>1</sup>

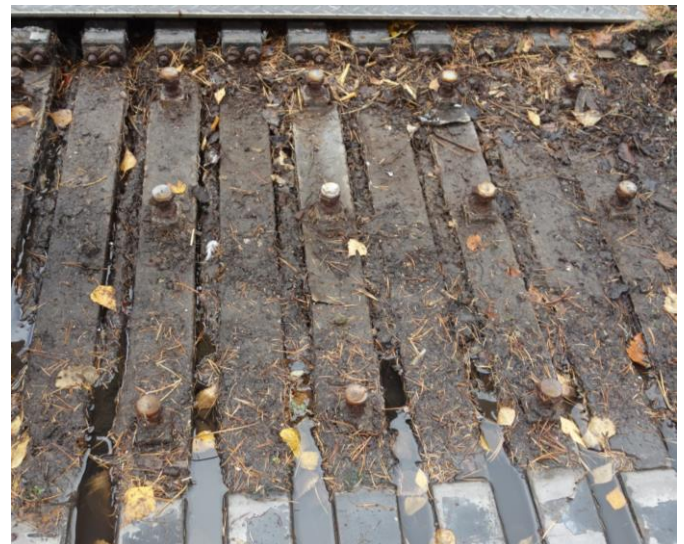
**Figure 2** Heavy accumulation of dirt; chipping and flaking of the organic coating. Source: IKS Dresden GmbH

Damages of fatigue result from use and the corresponding wear. They are favored by recurring high loads and irregular, too superficial maintenance or monitoring. Examples of wear-related damages are crossbeam or lamella fractures, chipping of coatings (see Figure 2) as well as deformation of the lamellae, defective sliding plates and spring bearings, sliding bearings and sliding springs that have fallen out.

System-related damages arise from the actual purpose of the construction. For example, watertight systems are intended to protect the substructure from moisture, but are susceptible to soiling and clogging of the sealing profiles between the lamellae (see Figure 2), which in turn can result in restricted movement of the lamellae or loosening of the sealing profiles. Noise reduction elements impede the

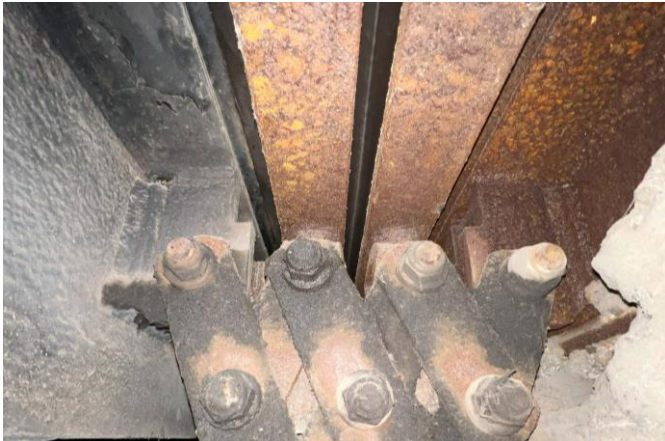
**Figure 3** Heavily corroded lamellae and scissor mechanism. Source: Author

self-cleaning capability often attributed to modular expansion joints in exchange for a quieter transit. System-related damage also includes corrosion damages (see Figure 3) that occur as a result of leaks in the sealing profiles themselves or under-rusting.

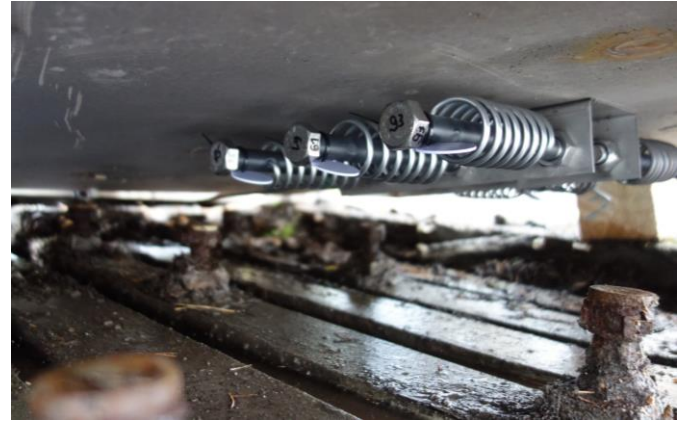
**Figure 6** Coils installed underneath a cover plate. Source: IKS Dresden GmbH

The verification of the actual corrosivity category, taking into account the microclimates in the area of the expansion joints, is part of the ongoing research project FOSTA P1574. Standard test specimens are used for this purpose. Both coils and plates made out of steel and zinc are placed at the critical points of interest. These include low points where water and all its impurities can collect (see Figure 6), the area of spray mist next to the roadway

(see Figure 7) and the area in the abutment beneath the expansion joint (see Figure 8). The special feature of the low points is that they are sometimes closed off with cover plates. Therefore, ventilation is mostly prevented. This is where the greatest corrosivity is expected. The rate of wear of the steel and zinc standard test specimens is determined in parallel with environmental measurements. All test specimens are exposed for 1 year at each of the three chosen sites.

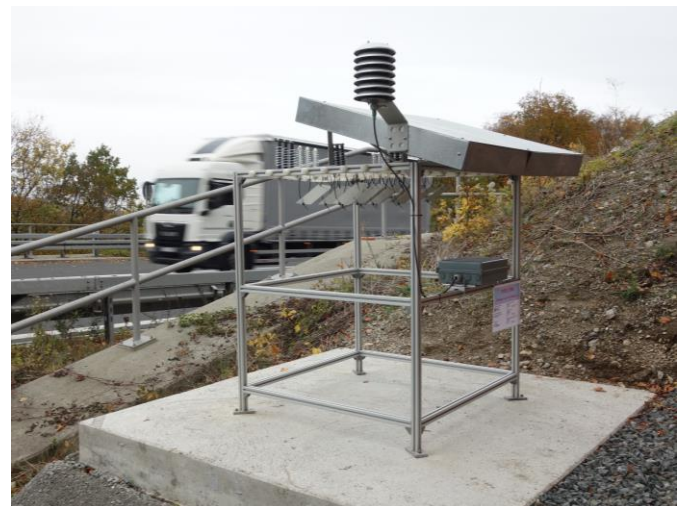
**Figure 7** Coils and plates installed on a weather stand. Source: IKS Dresden GmbH
