Position-dependent mechanical characterization of the PBF-EB-manufactured Ti6Al4V alloy

Abstract

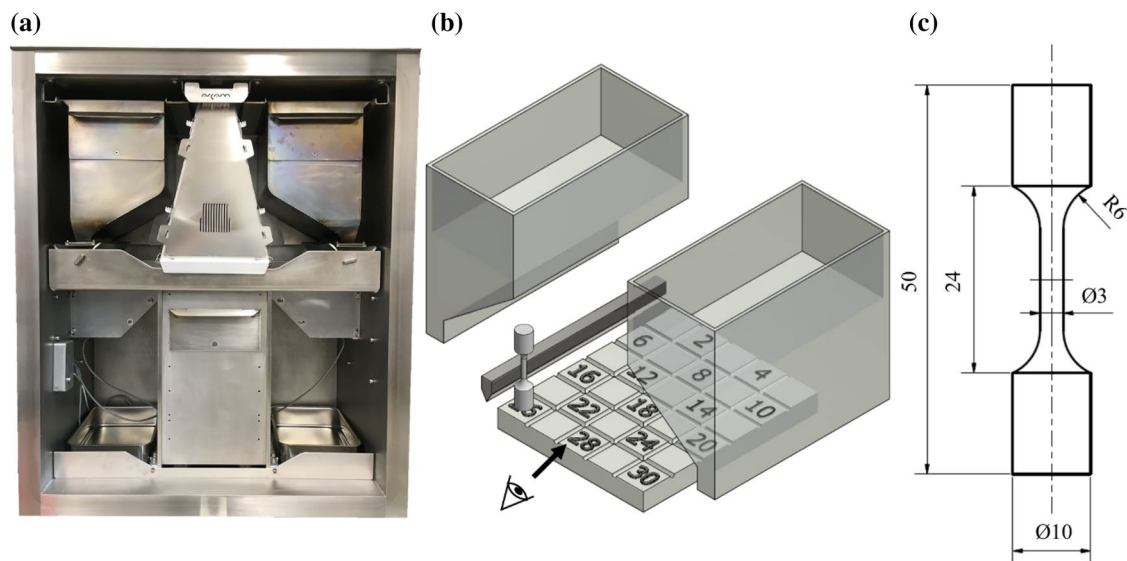
Fig. 1 a Arcam EBM A2X, b schematic illustration of segmentation of build platform and c the specimen geometry used for fatigue testing (dimensions in mm)

3 mm (Fig. 1c). A detailed figure regarding the segregation of the BP can be seen in Fig. 1a, b.

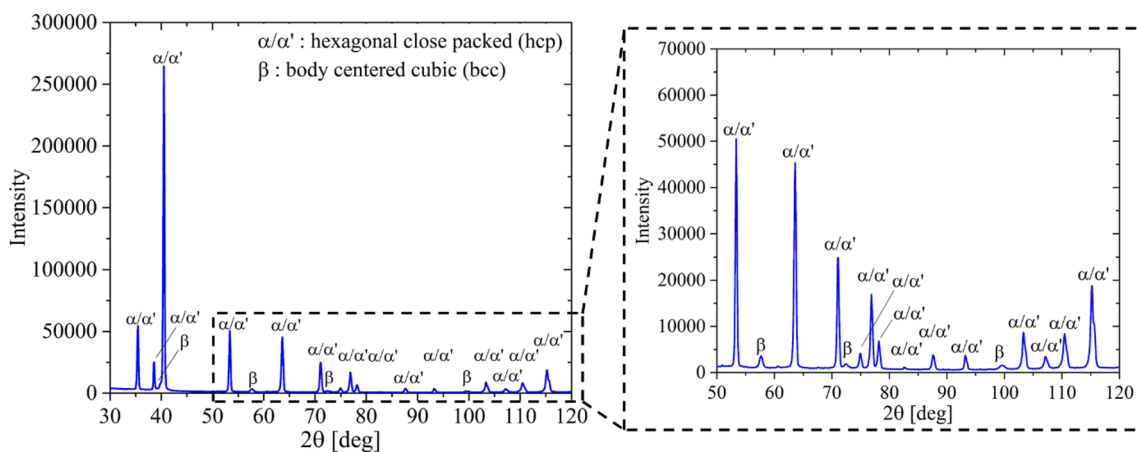
Fig. 4 XRD patterns of PBF-EB-manufactured Ti6Al4V alloy

In order to verify the existence of the β phase, additional XRD analysis was carried out. Figure 4 shows the

XRD pattern for the PBF-EB-manufactured Ti6Al4V alloy whereby the majority of the peaks can be attributed to the α/α' phase. Since α and α' have the same hexagonal close-packed (hcp) structure, a clear differentiation between both phases is challenging [10]. However, it was already reported in [1, 11] that the α' phase can be completely eliminated during the PBF-EB process. Next to the α/α' phase, even the body centered cubic (bcc) β phase is present (cf. Fig. 5), which was earlier reported by different researchers [13, 22].

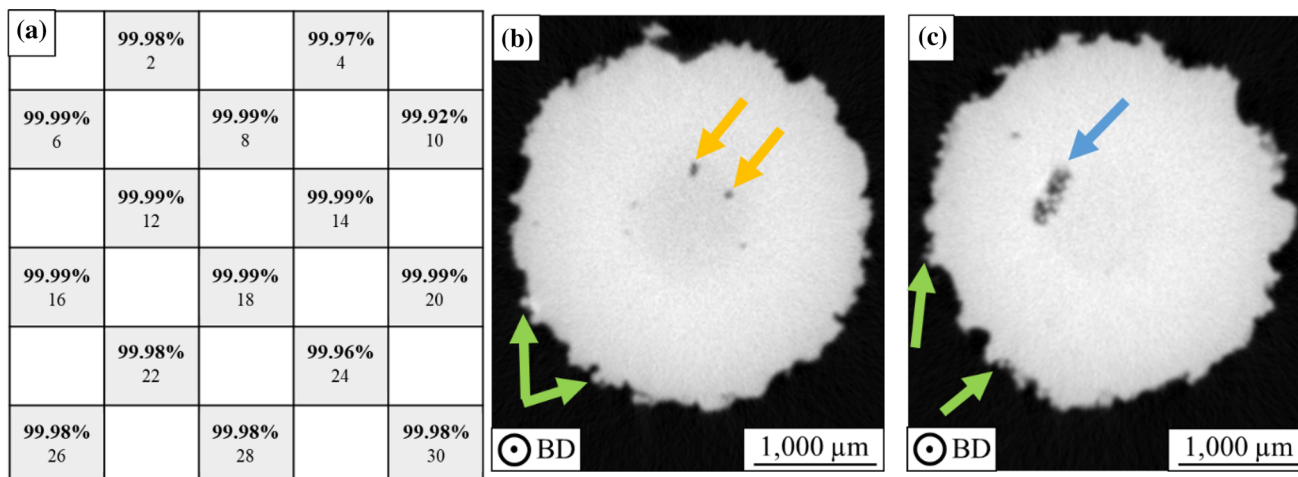
Fig. 5 a Values for relative density according to the positions on the building platform and 2D CT images from cross sections of specimen 10 showing predominantly b gas pores and c lack of fusion (LoF)

As mentioned above, pore analysis was carried out based on 2D images which were extracted from the reconstructed μ -CT volumes. Taking into account the complete BP, it can be stated that no big differences or regularly appearing deviations in relative density are present (cf. Fig. 5a). Smallest relative density was found to be 99.92% for specimen 10. However, specimens in direct vicinity (e.g., specimen 8, 14, 20) even show highest relative density. Since all values

only show differences in the second decimal place, it can be assumed that near fully dense specimens were manufactured. The remaining defects can be differentiated in two main pore types which can influence the fatigue behavior. The majority of all found pores are spherical shaped which is typical for gas pores having a diameter of approx. 20 μm. These circular pores are exemplarily shown in Fig. 5b (marked with orange arrows). In comparison, only a few elongated shaped and relatively larger LoF pores were detected. An exemplary LoF defect is highlighted by a blue arrow in Fig. 5c whereby a few unmolten powder particles can be observed inside the LoF defect. Furthermore, the combination of surface roughness, waviness and inaccuracy of the geometrical shape can be seen in the contour region in Fig. 5b, c, respectively. Green arrows exemplarily point out partially melted powder particles sticking on the specimens' surface.

As already stated in the introduction, the PBF-EB process enables the production of almost fully dense material [13, 14]. Based on the results, the average relative density of all investigated specimens was found to be $> 99.9\%$ whereby spherical shaped pores (cf. Fig. 5b) appeared more often than LoF defects (cf. Fig. 5c). Furthermore, pores occurred randomly within the volume and no pattern is visible. Similar results were even reported by Persenot et al. [24]. Typically, spherical pores can be attributed to entrapped gas in the powder particles. Varying the process parameters such as decreasing the scan speed and increasing the beam power can slightly prevent the development of gas pores, however, due to preexisting gas within the powder particles, gas pores

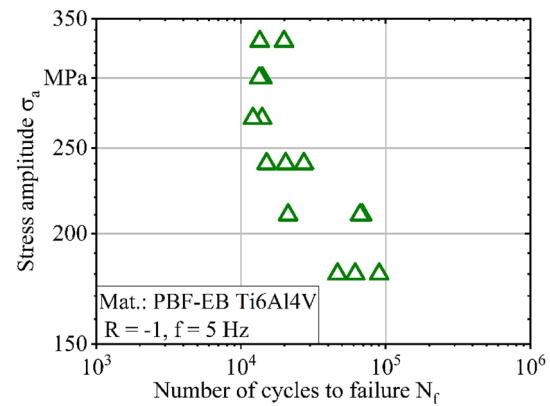
Fig. 7 Results from CAT plotted in form of S–N curves

The basis for the following fatigue tests are the calculated values for the average equivalent diameter which were introduced above. The fatigue tests were performed at different stress amplitudes to investigate the material's cyclic properties. The results are given in Fig. 7.

As can be seen, fatigue life values of as-built specimens are ranging between 10^4 and 10^5 cycles. For a stress amplitude $\sigma_a = 180$ MPa, a maximum number of cycles to failure $N_f = 90,200$ cycles was detected. However, for stress amplitudes ranging between 240 and 330 MPa, comparable number of cycles to failure were determined.

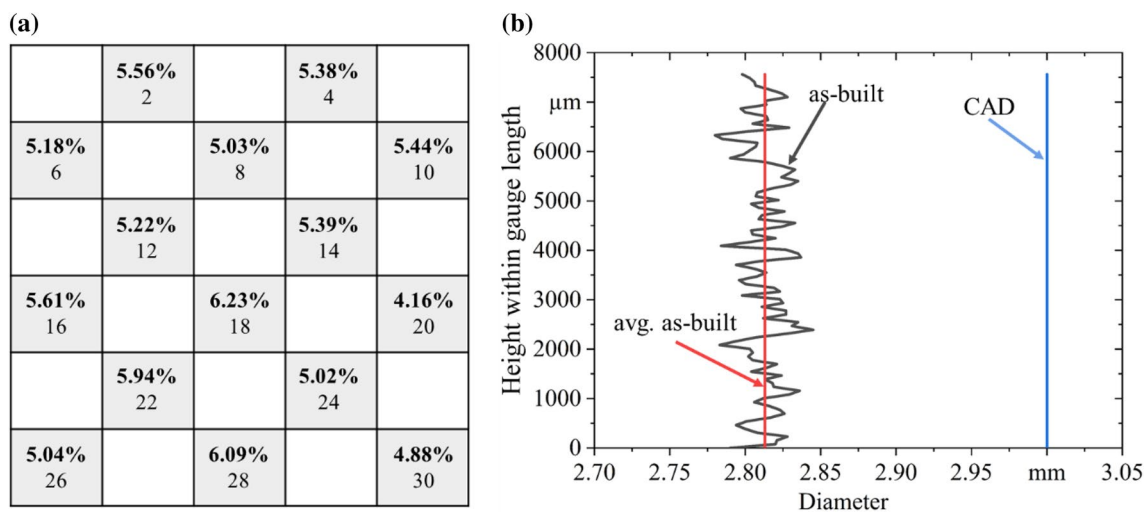
Fig. 6 a Local differences on building platform between CAD- and average equivalent diameter in percent in accordance with platform number. b Graphic depiction of cross section variations, average diameter and CAD diameter along building direction for specimen 18

PBF-EB-manufactured specimens can suffer from geometrical deviations when compared to the initial CAD data [19, 23]. Furthermore, these deviations can locally change with regard to the position on the BP. Therefore, average equivalent diameter was calculated for all specimens based on the μ-CT scans. The local differences between CAD and average equivalent diameter are plotted in Fig. 6a. In general, it can be stated that all sample cross sections are smaller than the prescribed CAD cross section and average deviation was found to be $-5.34 \pm 0.50\%$. In detail, specimen 20 showed the lowest deviation of -4.16% corresponding to the largest equivalent diameter which was found to be 2.88 mm. Highest deviation, in total -6.23% , was found for specimen 18 resulting in the smallest average cross section. The actual diameter for specimen 18 within the investigated gauge length is presented in Fig. 6b and is colored in black. The average equivalent diameter of 2.81 mm is marked in

red color and the CAD diameter of 3 mm is presented in blue, respectively. As can be seen, actual specimen diameter changes between single material layers which might lead to the formation of notch-like defects. Notch-like defects are typically described by their geometrical parameters such as depth and thickness of the notch as well as the radius at the lowest point [24]. The total amplitude of local diameter deviations ranges between 2.78 and 2.85 mm.

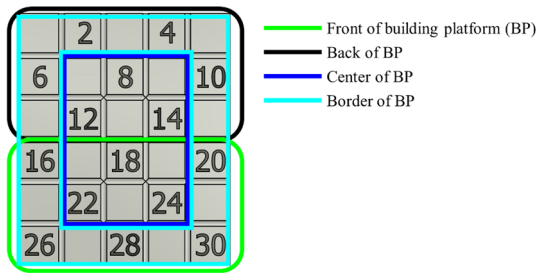
Fig. 8 Segmentation of the building platform

stress amplitude $\sigma_a = 210$ MPa. To further investigate the influence of the position of the BP on the fatigue life, the BP was divided into either front and back or center and border areas, as can be seen in Fig. 8.

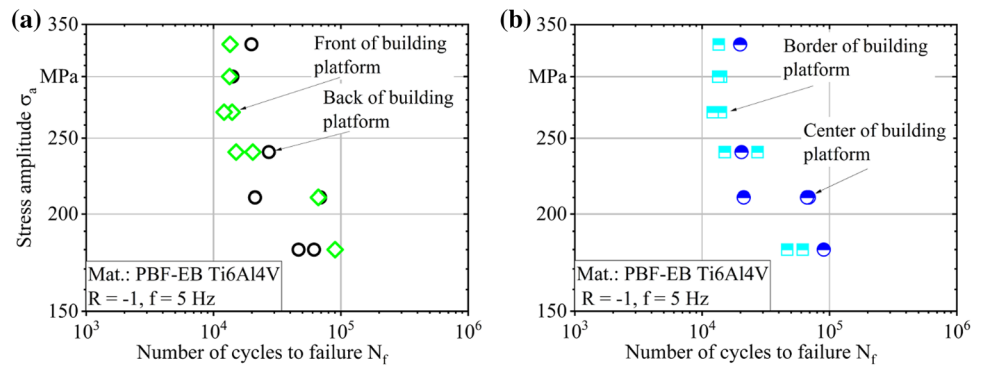
Fig. 9 Results from CAT plotted in form of S–N curves: differentiation between **a** front and back and **b** center and border of the BP

Based on this segmentation, specimens of each area were separately colored and results are plotted in Fig. 9a, b. In detail, specimens in the front of the BP are colored in light green, in the back of the BP in black, in the center of the BP in blue and in the border of the BP in light blue. Taking into account the results plotted, no clear influence of the position on the BP is visible. However, it has to be mentioned that specimens in the front of the BP show slightly weaker fatigue performance at higher stress amplitudes (cf. Fig. 9a). With decreasing stress amplitude, differences are reduced. Even specimens positioned at the border of the BP show lower fatigue life compared to specimens located in the center of BP (cf. Fig. 9b). This phenomenon can be detected at higher as well as at lower stress amplitudes. Solely specimen 14 ($\sigma_a = 210$ MPa, $N_f = 21,188$ cycles) shows a contrary tendency implicating that an individual irregularity led to

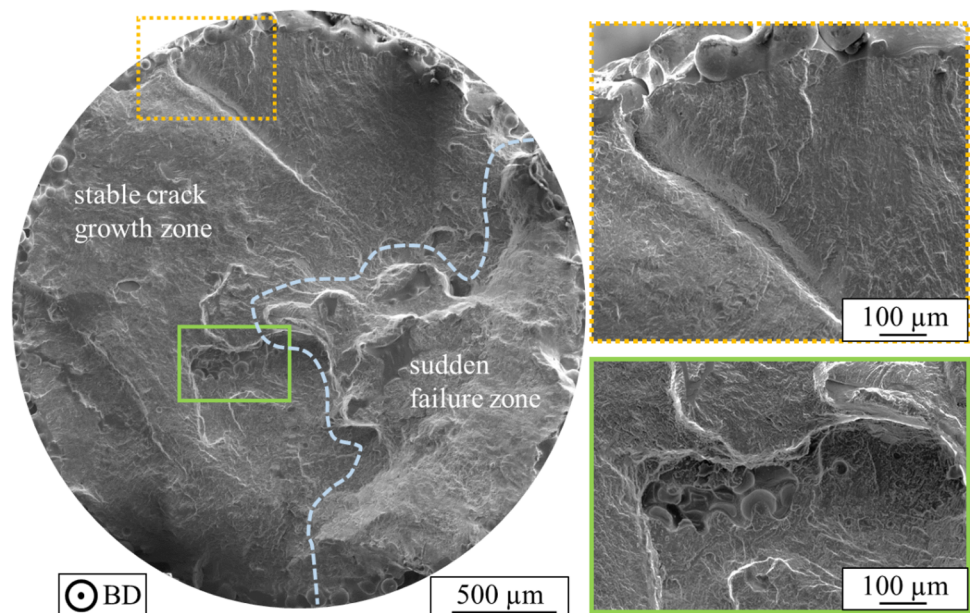
Fig. 10 Fracture surface of specimen 10 tested at a stress amplitude of $\sigma_a = 240$ MPa ($N_f = 27,210$ cycles)

The fractured surface of specimen 10 ($\sigma_a = 240$ MPa, $N_f = 27,210$ cycles), representing a specimen from the front of BP, was subsequently analyzed to localize the initiation of the fracture and to retrace crack growth mechanisms. The fractographic image as well as two magnifications are plotted in Fig. 10. As can be seen, the fatigue crack originated at the specimen surface which can mainly be attributed to the increased as-built surface roughness and near-surface defects leading to an irregular surface topography. However, based on the interaction of multiple factors, the fracture initiation cannot be attributed to a single origin. Furthermore, the fractured surface can be subdivided into two areas which are separated by a dashed line colored in light gray.

On the left side, the stable crack growth zone is clearly visible which is typically relatively flat and even. Within the stable crack growth zone, small spherical pores and certain LoF can be observed which are shown in higher magnification. Next to the stable crack growth zone, the second area shows a sharp and uneven surface which is characteristic for the sudden failure zone. In this zone, the specimen failure is caused by an overload fracture.

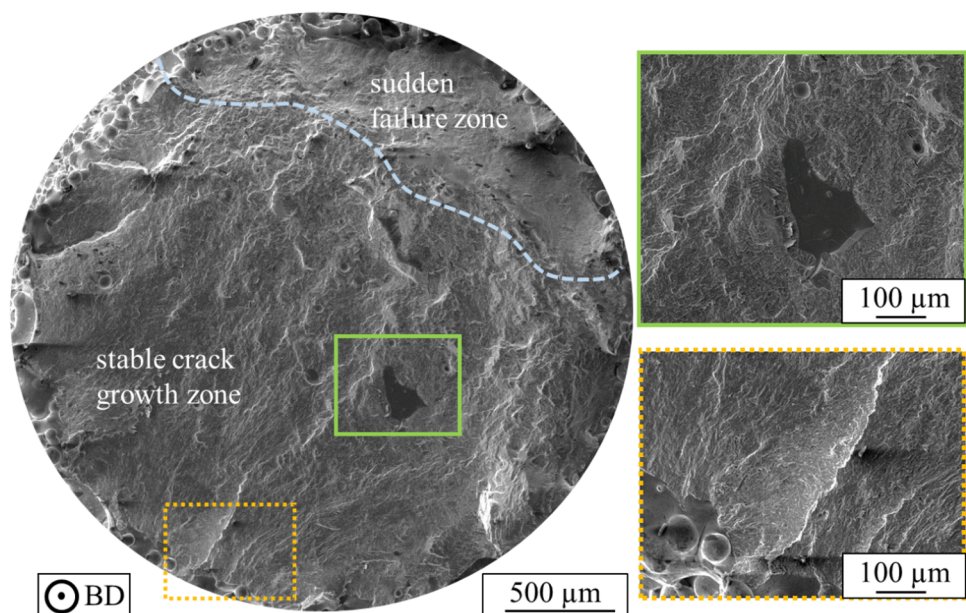
Fig. 11 Fracture surface of specimen 14 tested at a stress amplitude of $\sigma_a = 210$ MPa ($N_f = 21,188$ cycles)

For comparison, the fractured surface of specimen 14 ($\sigma_a = 210$ MPa, $N_f = 21,188$ cycles) is shown in Fig. 11. This specimen is located in the back of BP and showed relatively low fatigue life during CAT. As can be seen, even here, multiple crack initiation sites are present and fatigue crack initiated at the surface.
